Flightfax[®]

Online Report of Army Aircraft Mishaps

Major Accident Review (MAR)

RMIS Case # 20110526002

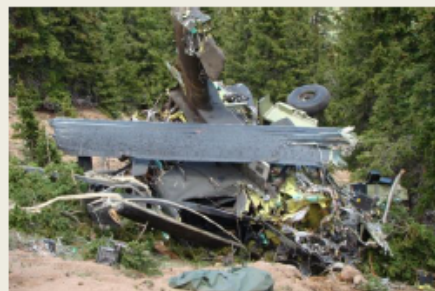
An AH-64D was conducting a mountain landing at 12,200' when rotor RPM decreased. The aircraft crashed on the mountainside.

Accident Summary: An AH-64D was conducting an NVS approach to a mountain HLZ located at 12,200 ft MSL as part of a high-altitude mountain environment training program. On short final to the pinnacle/ridgeline HLZ with only IGE power margins available, the aircraft slowed below ETL. This resulted in an increase in required power which exceeded the available engine power for the environmental conditions. As a result, the aircraft rotor rpm decreased and the aircraft settled and impacted the mountainside while trying to execute an escape plan.

- PI failed to maintain airspeed above ETL while still in an OGE condition in contravention to task 1058 in TC 1-251 which resulted in the aircraft exceeding its performance capabilities.
- IP failed to initiate corrective action in a timely manner to avoid the hazards associated with a slow VMC approach in OGE conditions to a pinnacle/ridgeline IAW Task 1058 in TC 1-251.

- Ensure aircrews operate aircraft within the required aircraft performance capabilities and flight limitations.
- Ensure all pilots in a leader or supervisory role take appropriate and timely actions to prevent or stop violations of safe operations.
- Update the unit risk assessment worksheet to reflect the varying increased risks associated with mountainous operations.
